**Royalpark Place  
Catchpit Safety  
Review  
Stage 1**

# Royalpark Place Catchpit Safety Review

## Stage 1

**Report Title:** Royalpark Place Catchpit Safety Review – Stage 1

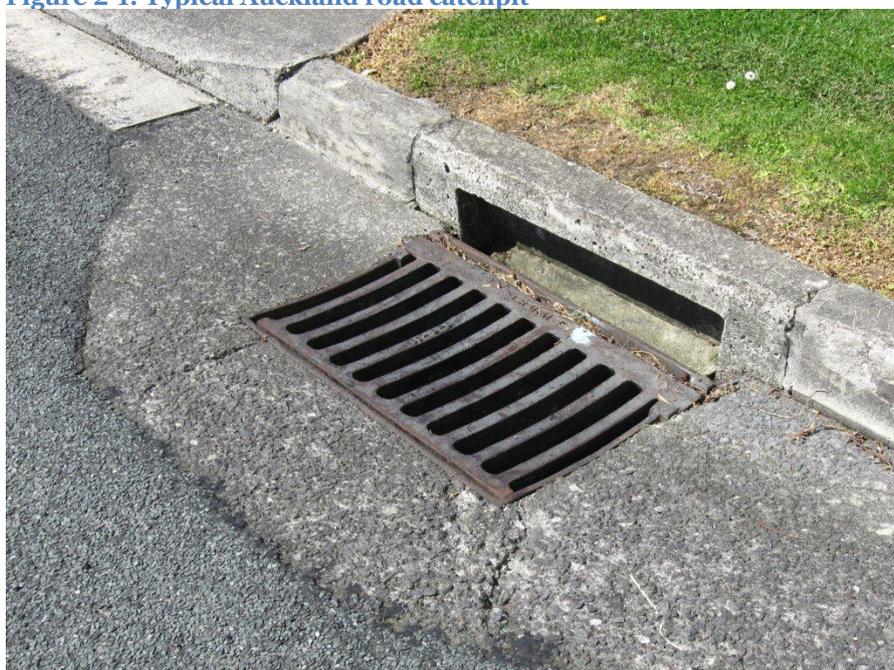
Figure 2-1: Typical Auckland road catchpit

A typical road catchpit is as shown in Figure 2.1. This catchpit has been in use in Auckland for over half a century. Over the last 10-15 years a larger variety of catchpit types have developed in response to a need for improved hydraulic performance and due to changing road use e.g. cycle friendly grates. A variety of catchpit sizes and configurations are now available across the New Zealand market, from small, plastic grates typically used in private property, through to large reinforced concrete 'megapit' devices with galvanised steel grates used to drain larger catchments or high risk flooding areas. Auckland Council and Auckland Transport currently specify five different types of catchpits as suitable for public infrastructure (refer Appendix A).

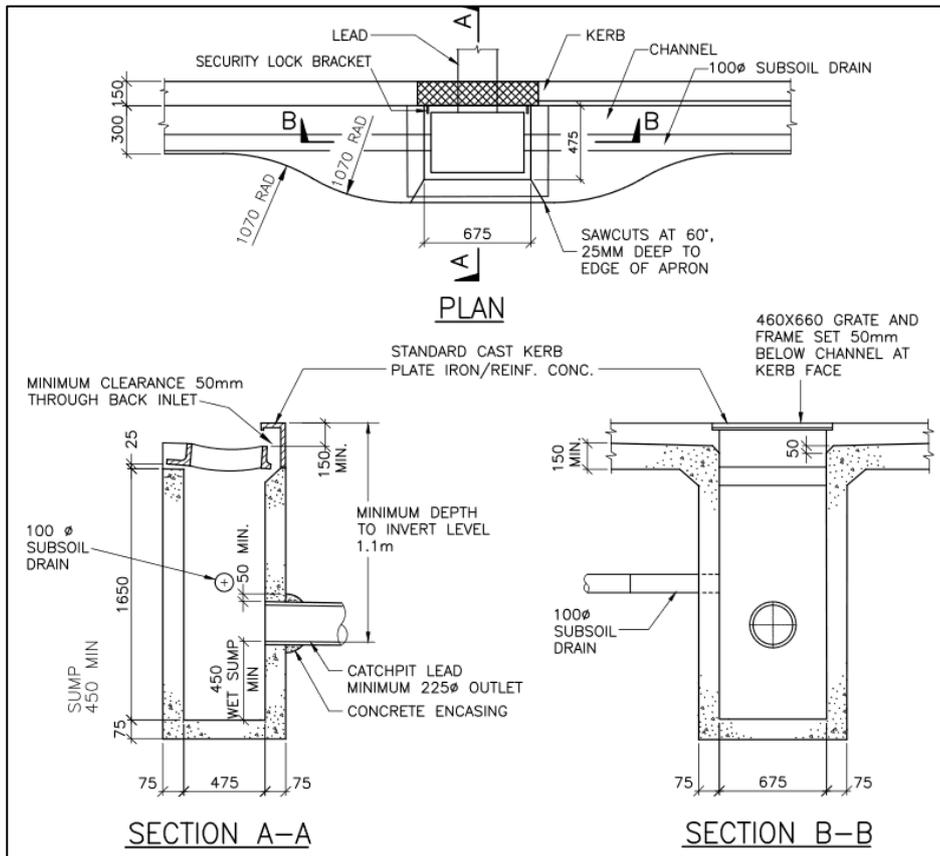
**Figure 2-2: Standard Catchpit detail**  
(Auckland Transport Code of Practice 2013- Road Drainage)

Despite the large variety of catchpit grille types, typical catchpits are predominantly made up of the same features (refer Figure 2.2):

1. A cast iron grate to collect runoff. The grate is heavy, and contractors usually use a specialist tool to enable access for maintenance. Most existing catchpits around Auckland are made of cast iron (CI) which has been used for many years. Some new catchpits are being manufactured with ductile iron (DI). This was due to the inherent strength of DI making it more suitable for higher load rating situations, such as container terminals, ports or transport warehouses. Ductile Iron has much more impact and fatigue resistance as opposed to the brittleness associated with cast iron (*email correspondence 31/07/17, Steve Martin, Hygrade Products*). DI is often also used for ‘cycle friendly’ grates and is also generally lighter than cast iron grates (refer Table 2.2). High capacity catchpits (e.g. megapit) are being manufactured with galvanised steel grates. Grates manufactured in the last 10-12 years are cast with bolt holes to enable them to be fixed to avoid theft.

2. A ‘back entry’ inlet to collect higher flows during more intense rainfall events. A minimum 50mm through to a typical maximum of 150mm. Typically these have an opening of 100mm. This opening is consistent with the 100mm spacing for vertical components specified in the Fencing of Swimming Pools Act 1987.

3. A reinforced concrete chamber, typically 1.4-1.8m deep.
4. The chamber includes a sump below the outlet pipe. Silt and sediment within runoff can settle and be collected within the sump, rather than discharge into the downstream environment. The sump is typically 450mm above the floor of the pit, however this can vary depending on the level of the outlet pipe. The sump is normally part full with water.

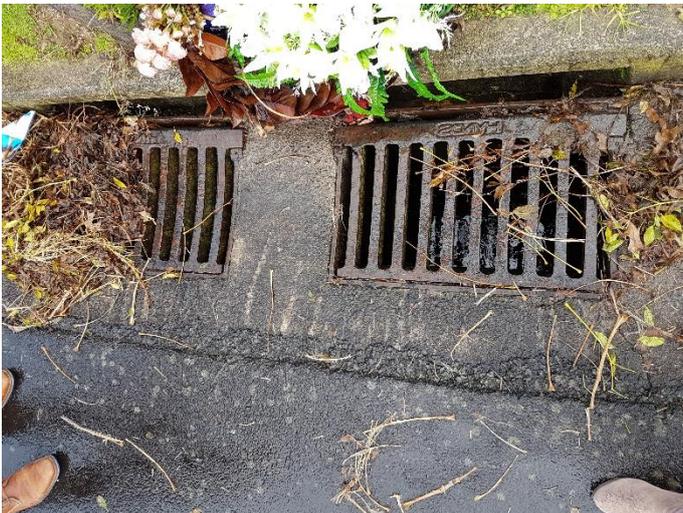
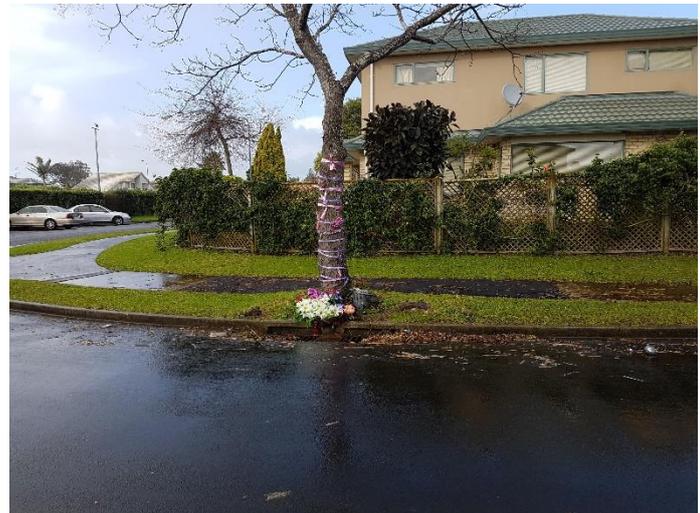
**Figure 2-3: Photos of the stormwater catchpit involved in the recent incident in Favona, Mangere**

The Royalpark Place catchpit is typical of standard catchpits found across the Auckland Region. The parameters of the catchpit involved in the recent incident are described in Table 2.3. The location consists of two adjacent catchpits (a double catchpit) linked by a small section of pipe.

**The catchpit grate weight of 48kg indicates it is effectively a Class C (or equivalent). The standard type of catchpit is now only manufactured as Class D, weighing 62.5kg. The lower class catchpits are no longer manufactured for the Auckland market (telecoms Steve Martin, Hygrade Products, 23/08/17).**

Parameter	Dimension
Grate Size	675 x 450 mm
Catchpit Box Internal	650 x 450 mm
Grate material	Cast Iron
Grate weight	48 kg
Depth	1.25m (approx)
Sump	340mm (approx)
Back Entry	100mm

2. **The catchpit at Royalpark Place involved in the recent drowning was typical of catchpits found across the Auckland Region, with a 675mm x 450mm cast iron grate and 100mm back entry. The catchpit grate weight of 48kg indicates it is Class C (or equivalent), which was commonly used across Auckland. This standard type of catchpit is now only manufactured as Class D, weighing 62.5kg. Lower classes of catchpits are no longer manufactured for the Auckland market, however many are still in use across the Region.**

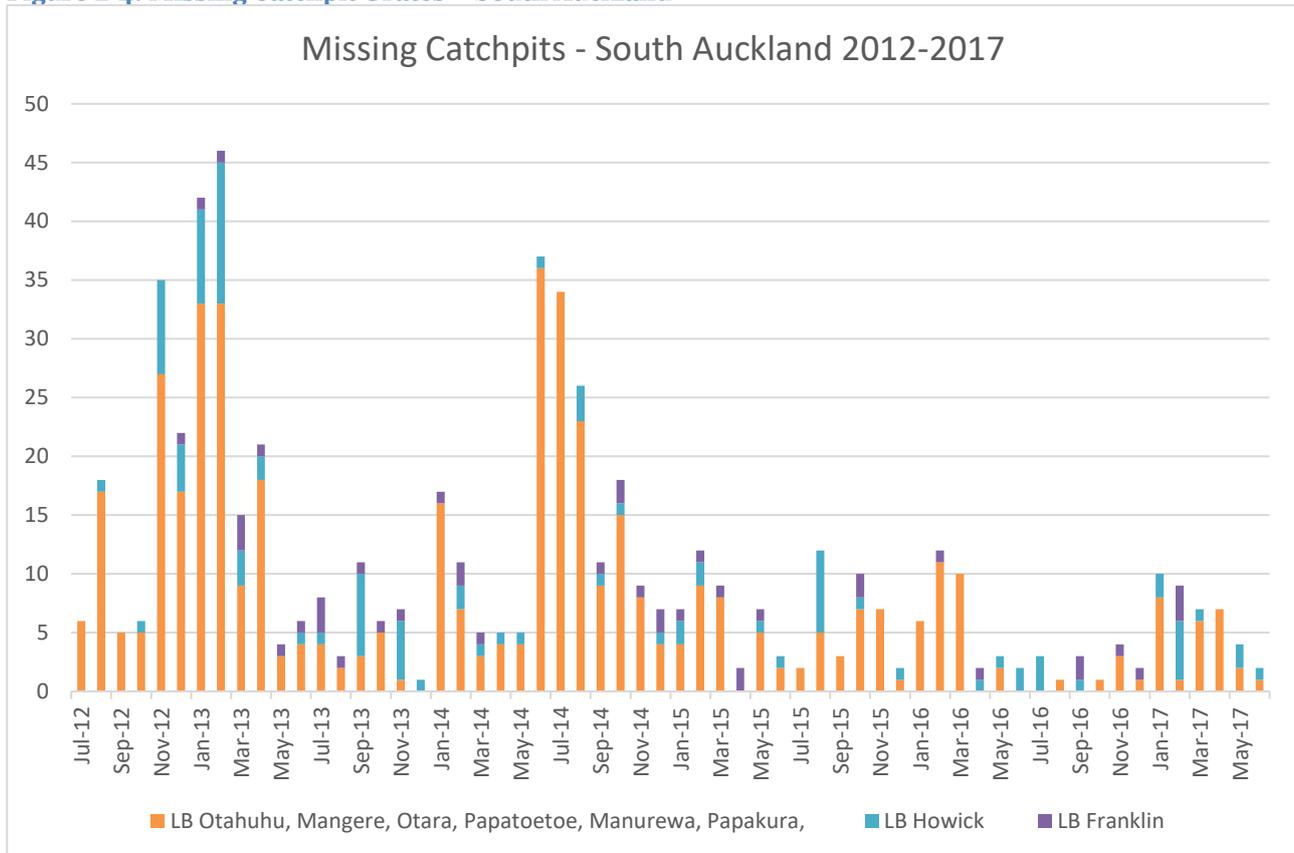
Figure 2-4: Missing Catchpit Grates – South Auckland

Catchpit grates occasionally go missing across the Auckland Region. AT report 599 grates that have gone missing in South Auckland over the last five years (Figure 2.4). There has been a general reduction in number of catchpit grates going missing potentially due to a drop in the price of scrap metal over the same period.

In addition, Auckland Council Healthy Waters department have replaced 52 missing grates across the region over the same period. Auckland Transport has advised there are approximately 31,500 catchpits in the South Auckland urban area, therefore approximately 0.4% of South Auckland's catchments have gone missing on average per year over the last 5 years.

**Missing catchpit grates represent a significant safety risk to the public. If a missing grate is reported by the public, Auckland Transport treat it as an emergency incident and responded to within 1 hour.**

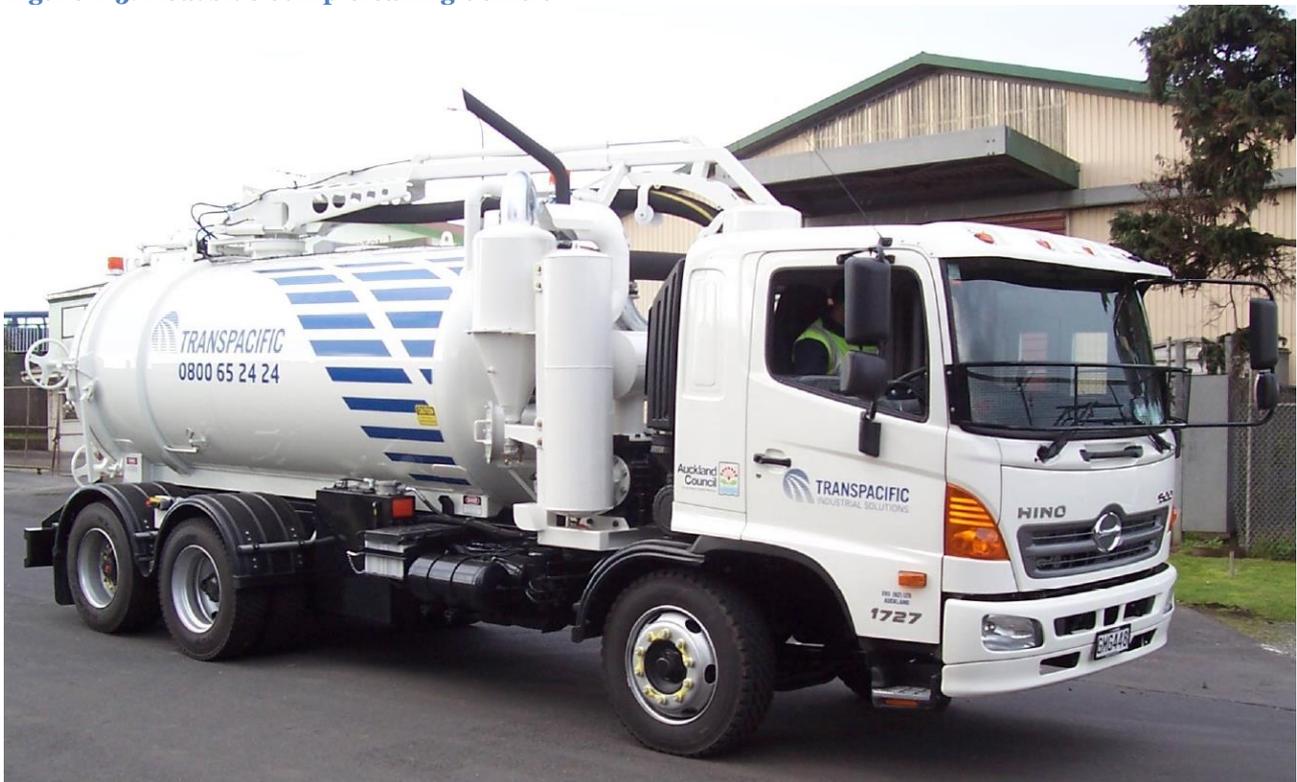
**Figure 2-5: Roadside Sump Cleaning Vehicle**

- a) The RSCV is parked in close proximity to the catchpit.
- b) The grate on the sump is opened by hand using a special tool to hook and pull up the grate.
- c) Next the drop pipe will be lowered into the sump until it gets to the bottom of the sump or to a build-up of sediment.
- d) The vacuum system is turned on and sediment sucked into the lower end of the drop pipe and into the truck until all debris is removed.
- e) If necessary, a water blaster can be used to assist in cleaning the sides of the sump.
- f) When all cleaning has been completed, the grating on top of the sump is replaced.
- g) Sump contents are disposed of at a specialist facility.

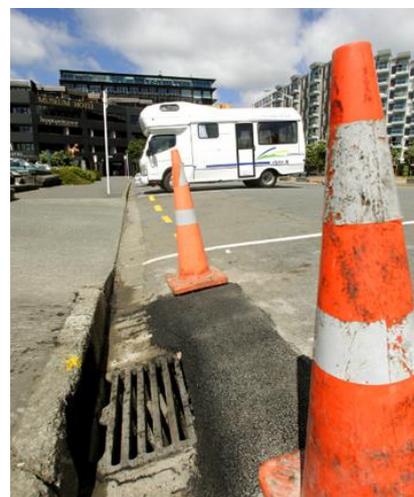
Figure 3-1: Site of drowning.  
Image courtesy of stuff.co.nz

On 14 January 2012, a 43-year-old man drowned after falling into a stormwater catchpit in the car park in Barnett Street, Wellington. Coroner Garry Evans' report stated that the man fell into the stormwater culvert (sic) in an attempt to retrieve his car keys which he had dropped down the culvert. The culvert was covered with a hinged metal grate. He was believed to have lifted the metal grate and reached in for his keys, lost his balance and fell head first into the water. Coroner's report states that Detective Senior Sergeant Thornton had concluded that it was probable the man's judgement at the time he attempted to recover his keys was severely affected by the alcohol he had consumed. His body was recovered by police the next day after a call received from a woman who had parked her car in Barnett Street.

Mr. Thornton's report shows the stormwater catchpit had water at a depth of 1.2m. He has stated that the man was unable to extract himself after falling into the culvert (sic) and appeared to have then been asphyxiated by the water in the culvert. A few hours after the incident a parking warden noticed that the metal grate had been lifted exposing the culvert. He had also seen a pair of boots in the drain but did not inspect the boots. He had closed the grate as he was concerned that a member of the public might accidentally fall into the exposed culvert. Coroner Garry Evans had concluded the man's loss of balance and his fall into the open catchpit was related to the alcohol he had consumed and, probably, his tiredness. Thereby **no recommendation was made to Wellington City Council in the circumstances.**

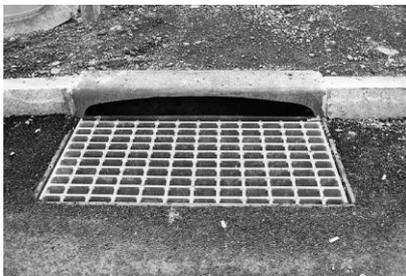
<p><b>Figure 4-1: Bicycle safe grate with drop inlet</b> (Pg. 17, US Department of transportation- Maintenance of drainage features for safety)</p>

USA	US Department of transportation- Maintenance of drainage features for safety 2009	<p><i>When bicycle traffic exists, grates should prevent the tires of a bicycle from slipping into and being caught in the grate. Therefore, bicycle safe grates should be used whenever bicycle traffic is expected. With a flush bicycle-safe grate, a bicycle tire cannot get caught in the grate because of the cross pattern of supports which results in only small openings. (Refer Figure 4.1)</i></p>

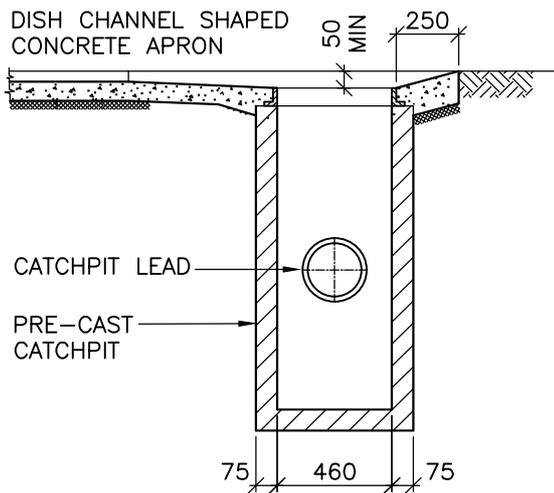
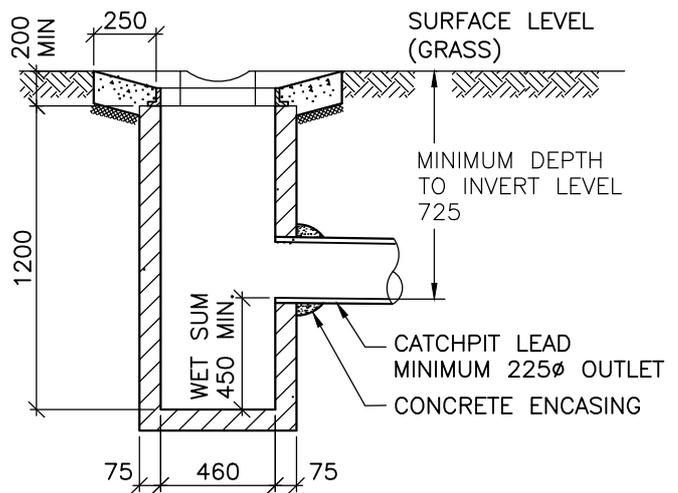
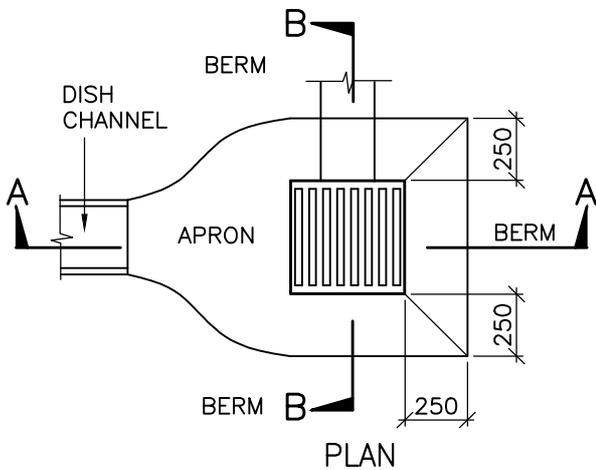
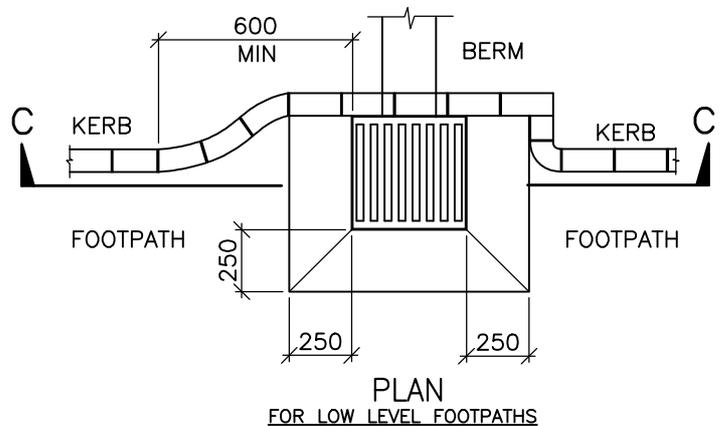
SCALE:	N.T.S.
DRAWING No.	RD030
VERSION

1. Concrete 25MPa, Fair faced finish.
2. Cast Iron hardware to be supplied ex. approved Foundry.
3. Half syphon to be used in combined catchment areas only.
4. Catchpits to be 1.4m deep.
5. For design purposes, inlet capacity = 10 l/s
6. Nominal Dimensions only. Refer "Manufacturers Precast Field Catchpit Specifications". Minimum wall thickness 75 mm, Sump depth 450 min. Minimum depth to catchpit lead invert 725mm in grassed areas.
7. Increase class of pipe where minimum cover of 900mm cannot be achieved for Catchpit leads.

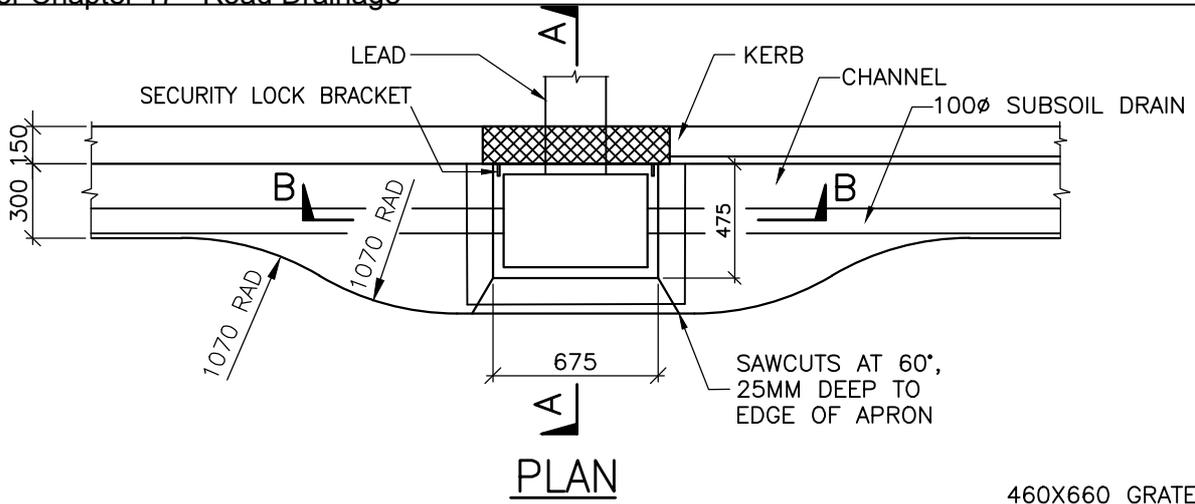
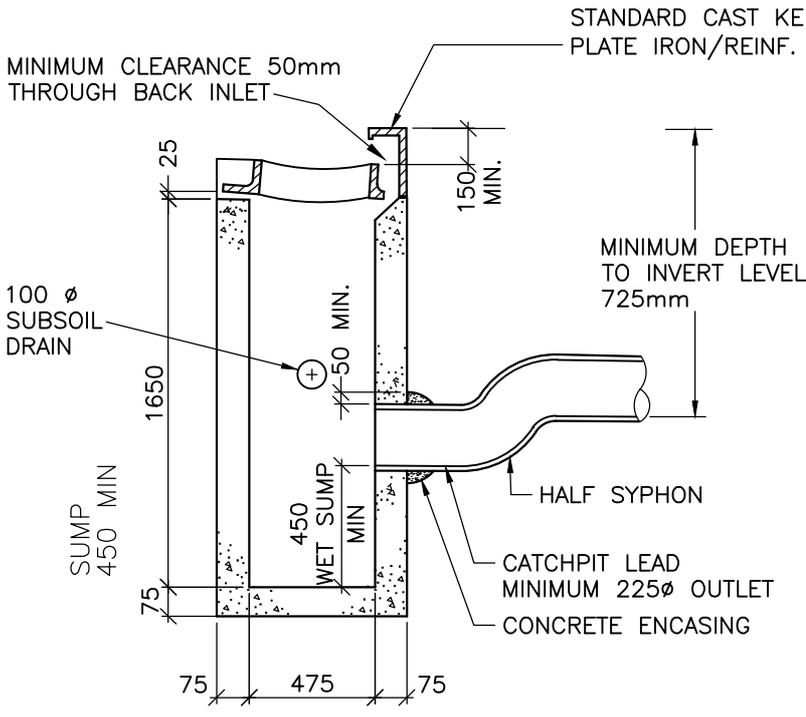
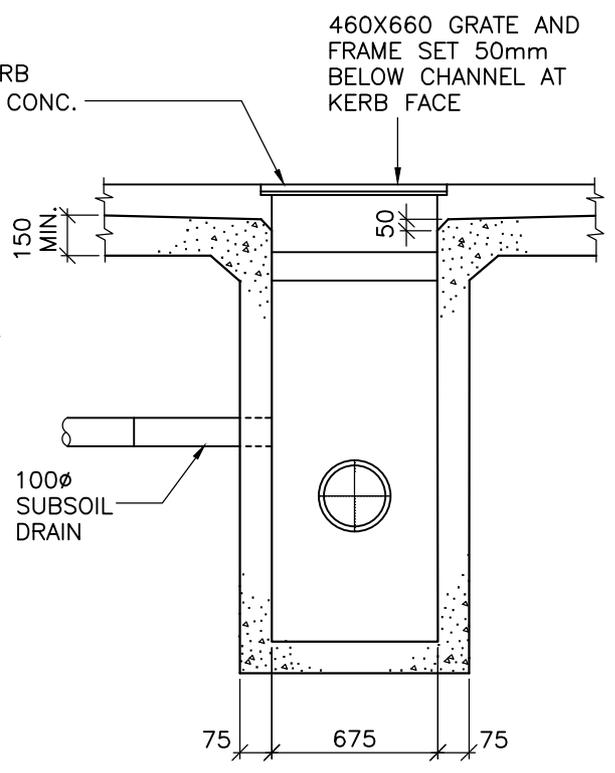
AUCKLAND TRANSPORT CODE OF PRACTICE		SCALE: N.T.S.
TITLE	<b>STANDARD CATCHPIT</b>	DRAWING No. RD034
		VERSION

1. Concrete to be 25MPa. Fair faced finish.
2. Cast Iron hardware to be supplied ex. approved Foundry. To include security lock bracket.
3. Where double pits are required, two back inlet units may be installed side by side.
4. For concrete kerbs and for bluestone kerbs use cast-iron back inlet.
5. Half syphon to be used in combined catchment areas only
6. Nominal Dimensions only – refer Manufacturers "Precast Back Entry Catchpit" specification. Minimum wall thickness 75 mm, sump depth 450 min. Minimum depth to catchpit lead invert 1.1m.
7. Increase Class of pipe for catchpit lead if cover under carriageway < 1.2m
